TELSCOMBE TOWN COUNCIL

AGENDA

10. Update on playground inspection reports & to agree actions – *see attached*
11. Update on management plan – *see attached*
12. To discuss findings from the preliminary bat roost assessment in Chatsworth Park – *see attached*

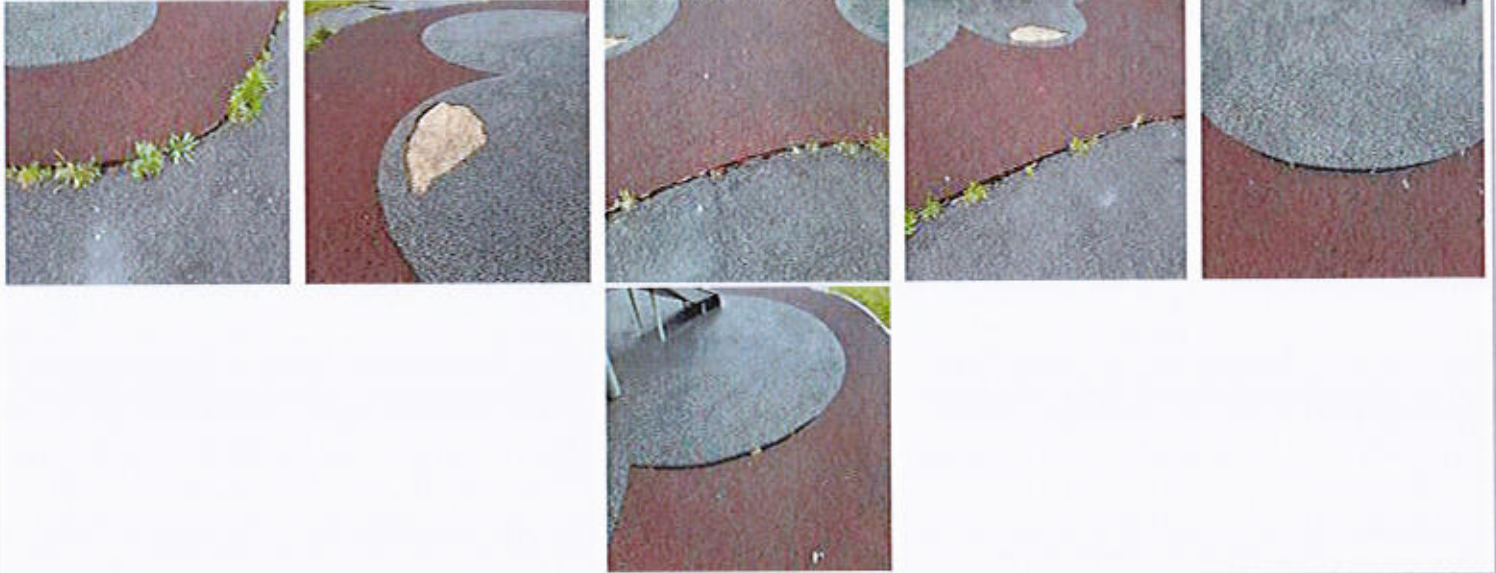
Finding Photos

Asset	Wet Pour
Finding Title	Ground Eroded
Finding Group	Maintenance
Cause	Wear and Tear
Finding Status	Open
Finding Creation Date	31/05/2022 07:28:43
Resolve By Date	
Finding Resolved Date	
Risk Level	Medium
Finding Notes	The wet pour edges are lifting in places and shrinking in others causing trip hazards. The hole in the wet pour is getting larger.

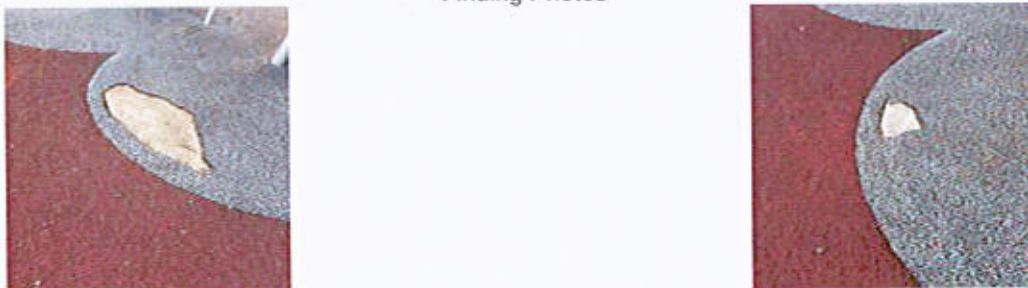
Finding Photos

Asset	Wet Pour
Finding Title	Item - Damaged
Finding Group	Maintenance
Cause	Maintenance
Finding Status	Open
Finding Creation Date	14/12/2021 10:12:46
Resolve By Date	
Finding Resolved Date	
Risk Level	Low
Finding Notes	28.6.22 Latest picture of the hole in the wetpour.

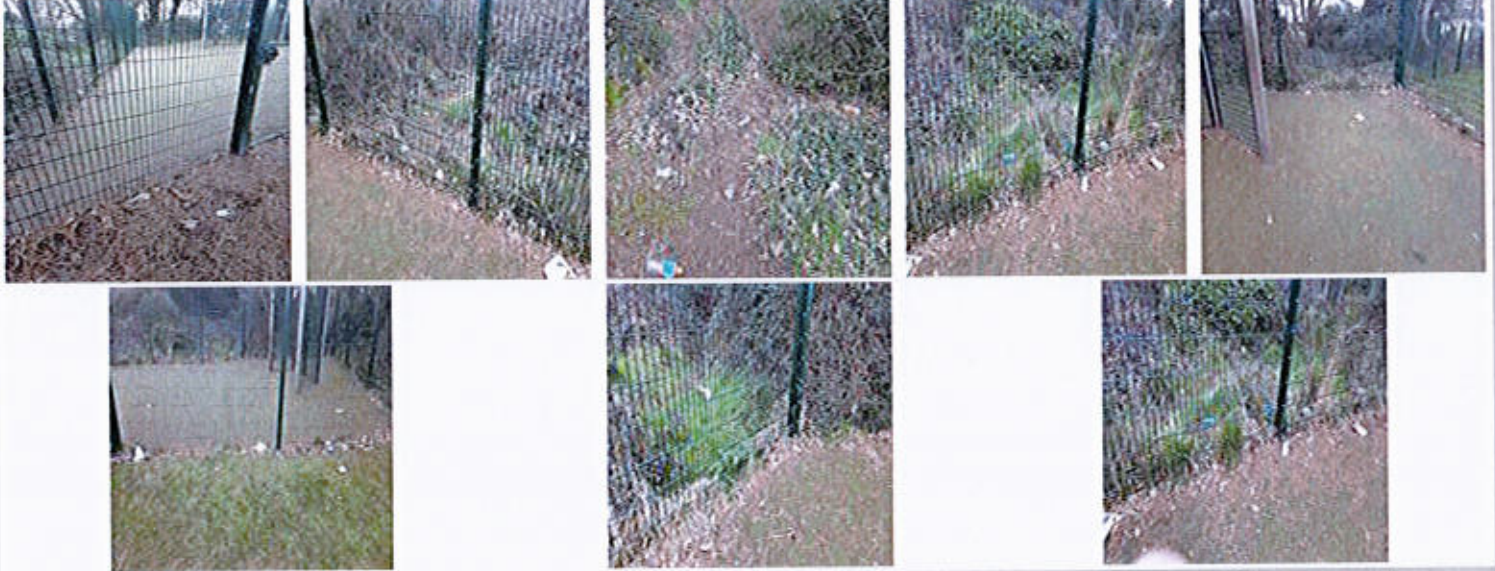
Finding Photos

Asset	Overall Site
Finding Title	Litter - medium amount
Finding Group	Maintenance
Cause	Anti Social Behaviour
Finding Status	Open
Finding Creation Date	08/02/2022 10:21:59
Resolve By Date	
Finding Resolved Date	
Risk Level	Low
Finding Notes	Reported to IdVerdi to remove.

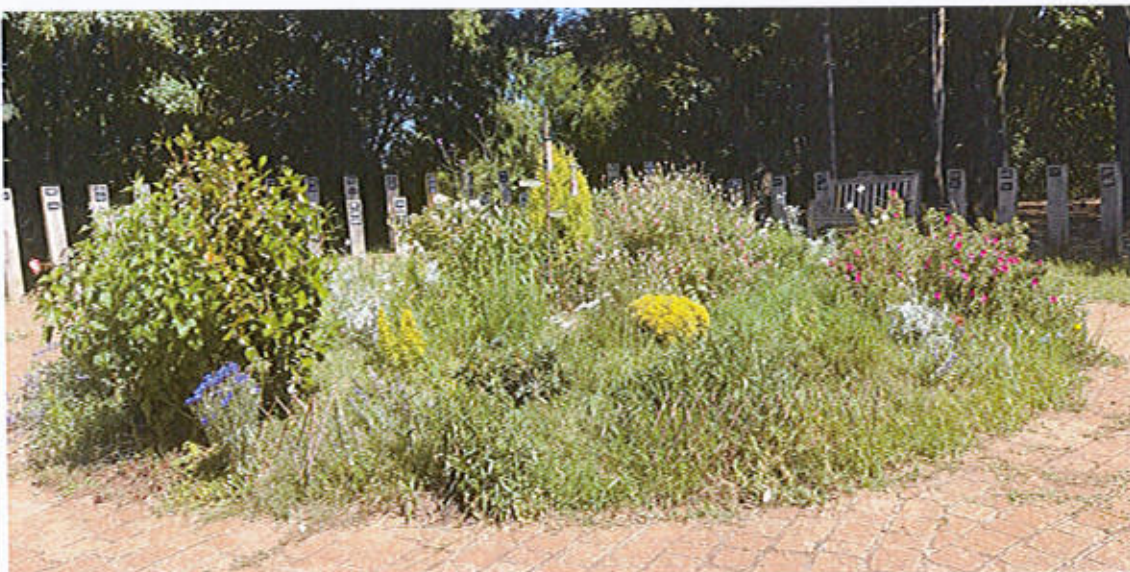
Memory Garden

Some of the posts have cracks, but these cannot be fixed. Going forward, we could replace the original green oak sleepers around the garden with timber sleepers, which

are cheaper, when they break. We could also treat the base with a protector once the new sleepers have been installed, to provide further protection. Some of the plaques are bowing, which happens when the wood expands in wet weather and contracts in dry weather. There are no safety concerns to both items, as well as the two donated benches, which are both in good condition. The Telscombe Residents Association recently re-painted their bench to provide further protection.

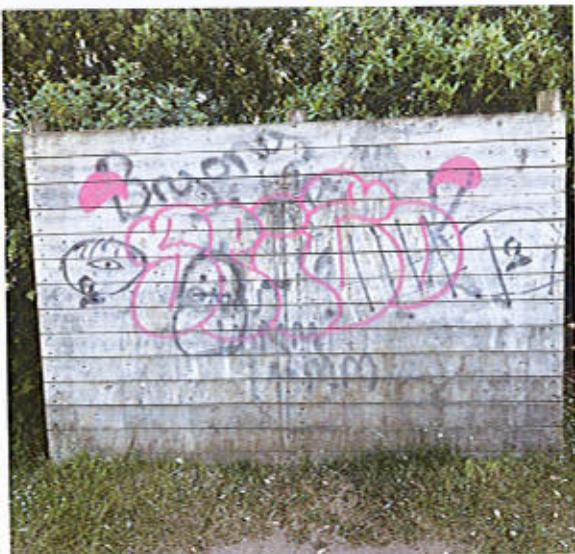
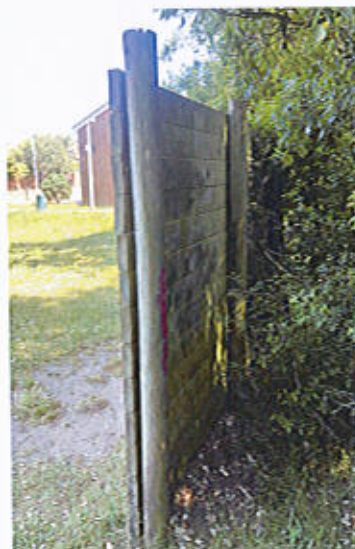
Zone 2

The ball wall is in good condition but has been subject to graffiti. This will be difficult to remove so we could ask a local youth group to spray a pre-agreed picture on the wall to cover what is already there.

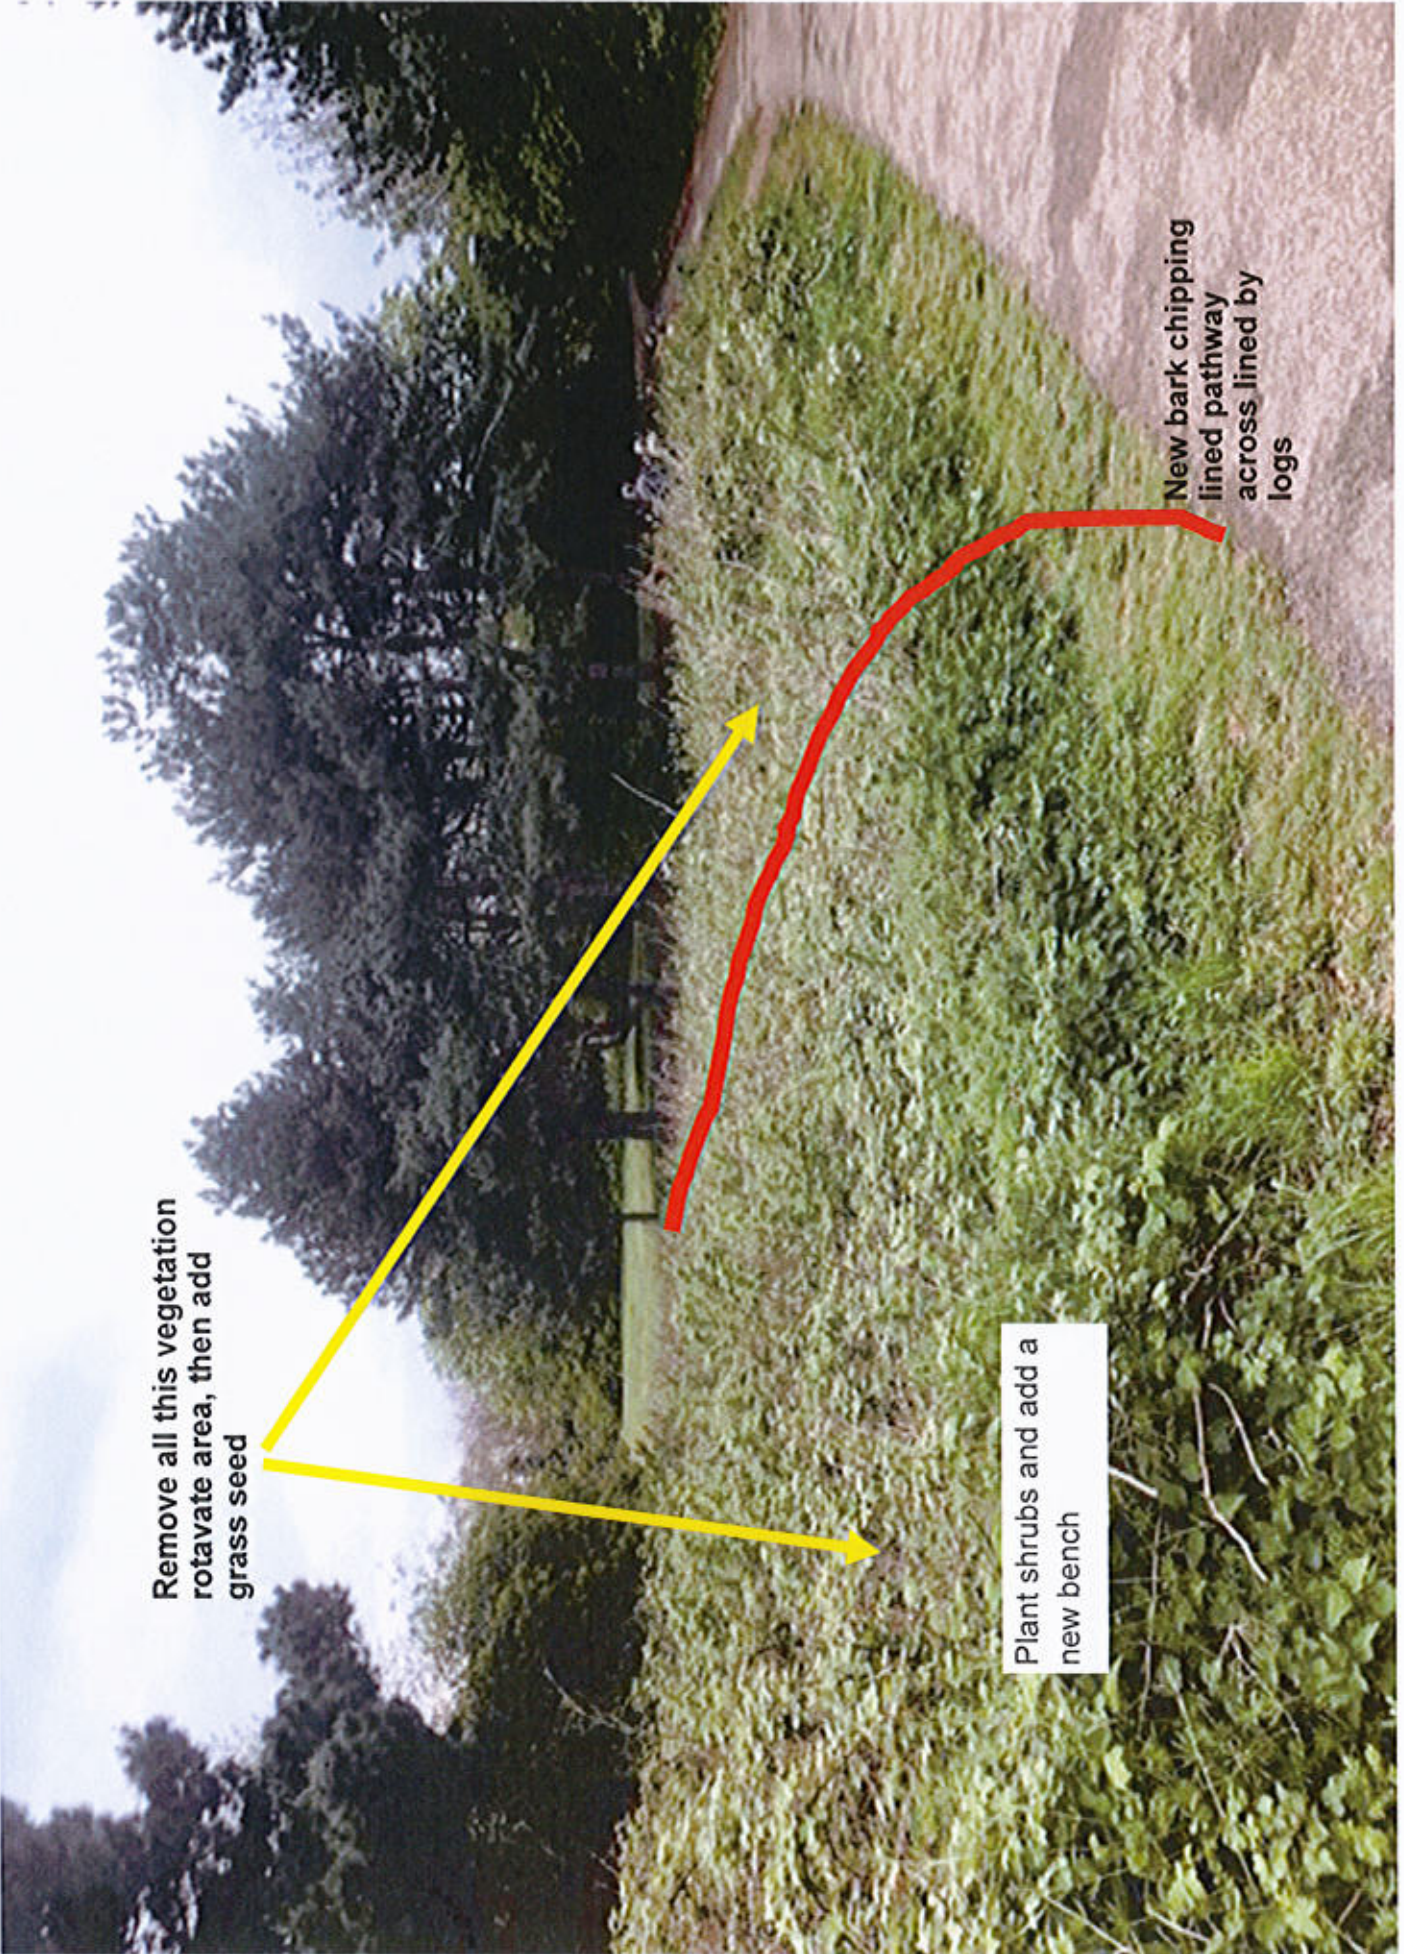
Remove all this vegetation
rotavate area, then add
grass seed

Plant shrubs and add a
new bench
